Charlottesville Downtown Mall **TREE MANAGEMENT PLAN**

2024

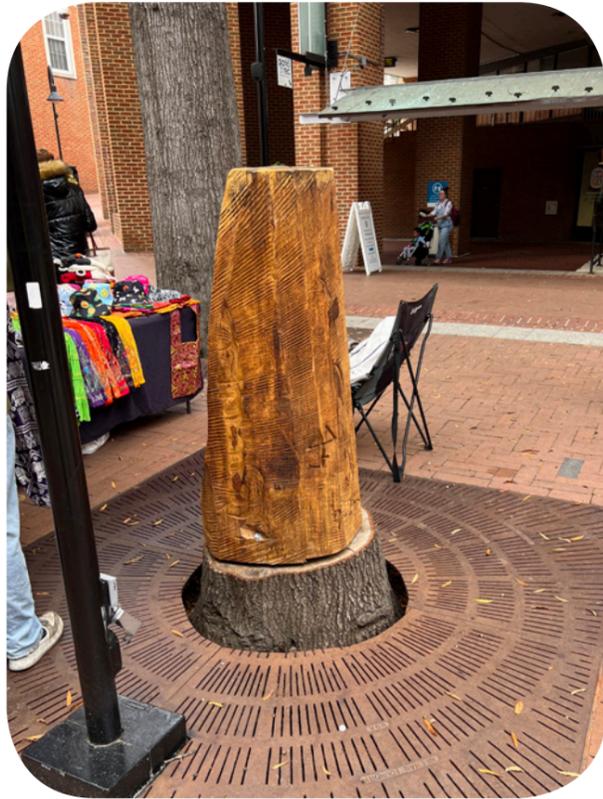
Willow oak #16

Comparing the current health of Mall trees and their existing conditions, if nothing is done to improve the health of these trees, further loss of up to 44% of the trees in the next 15 years is anticipated.

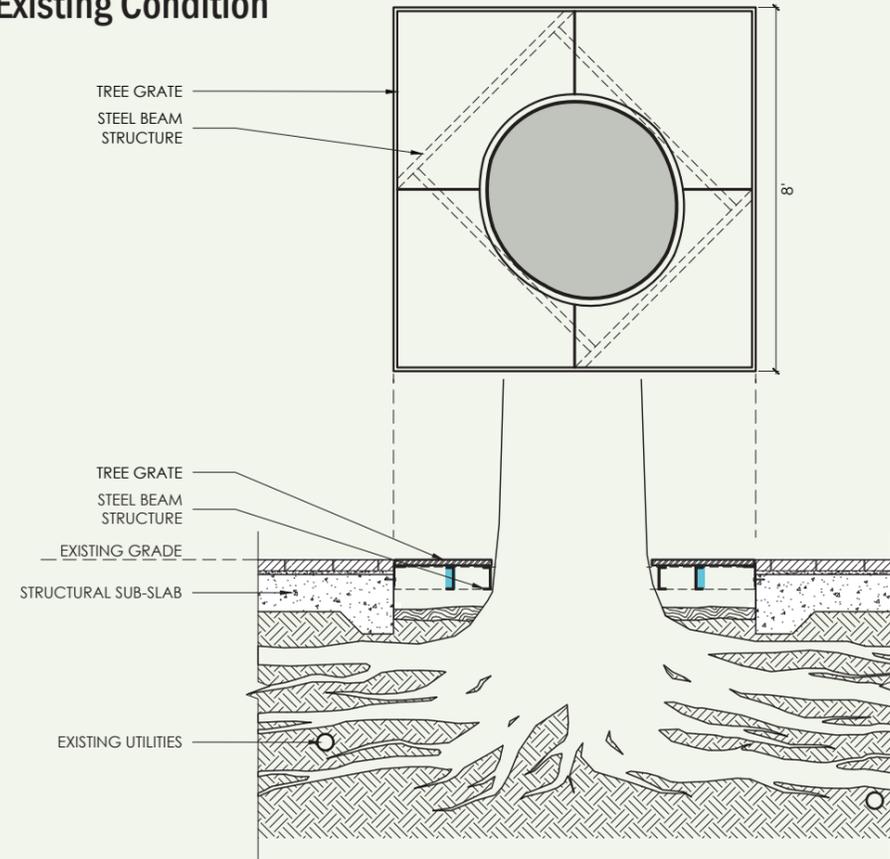
Existing Condition

- Trunk flare without girdling by grate beam supports

- Modify grate beams to reduce future conflict

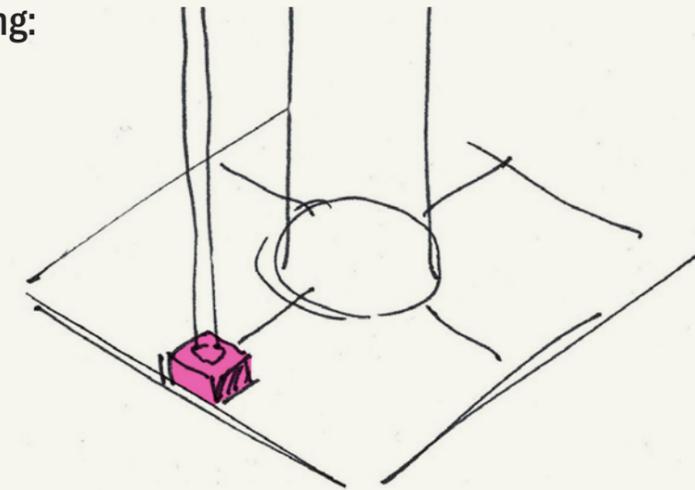
Existing:

The 2010 grate modification repositioned the light fixtures with their bases above grade, creating a trip hazard. It is recommended to move the light fixtures to the corners to increase the distance from the tree and lower the footings so they are flush with the grade.

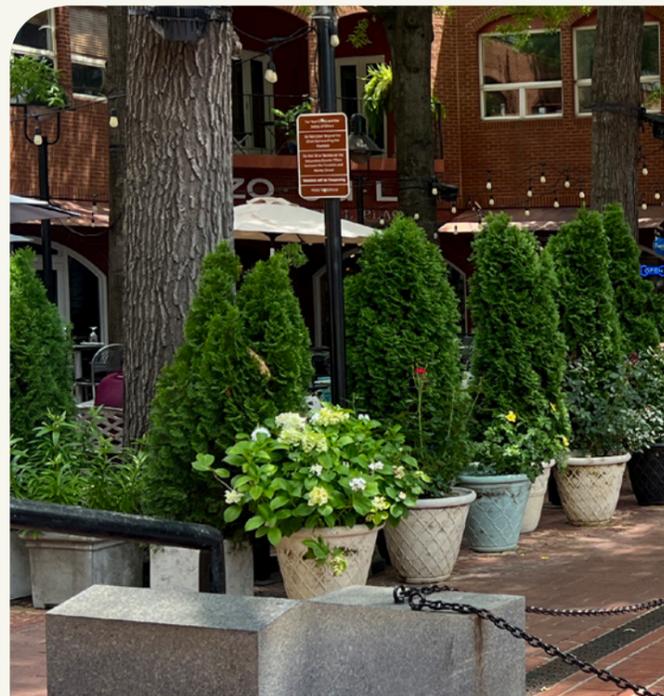
Potted Trees

- Tall vegetation (small trees) enclose and obscure base of trees
- Extensive use of pots obscures base of trees

To improve the experience, reallocating cafe seating, reducing visual clutter, and restoring access to the fountains is recommended. These changes would enhance visibility of the tree trunks and provide pedestrians with direct access to the fountains, enriching their experience of the Mall.

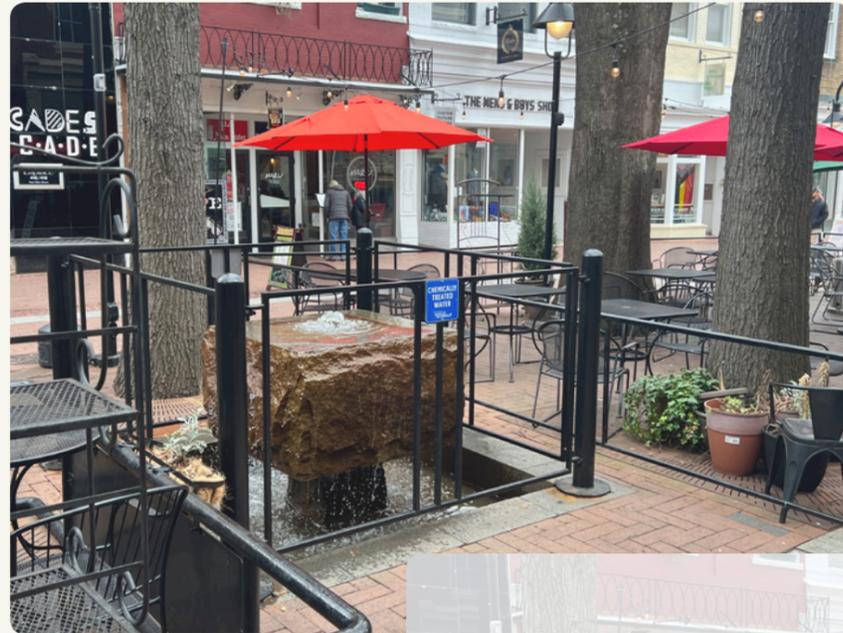
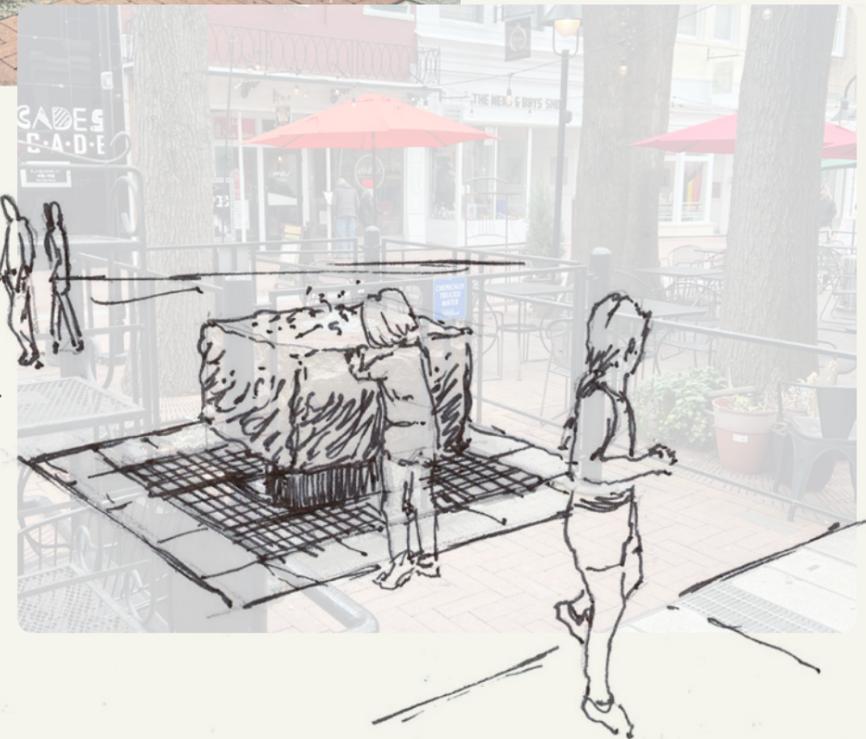
- Fountain fencing blocks the access

Due to trip hazard concerns, the large cascading fountain at Central Place and the three smaller spring fountains along the Mall have been fenced off, limiting pedestrian interaction and summer water play.

To address this, installing a metal grate surface that allows water to flow through while eliminating the trip hazard is recommended. This would make the fountains accessible again, turning them into lively centers of activity and play instead of unused, fenced-off spaces.

- Remove fencing
- Add metal grate for access
