Charlottesville Downtown Mall **TREE MANAGEMENT PLAN**

2024

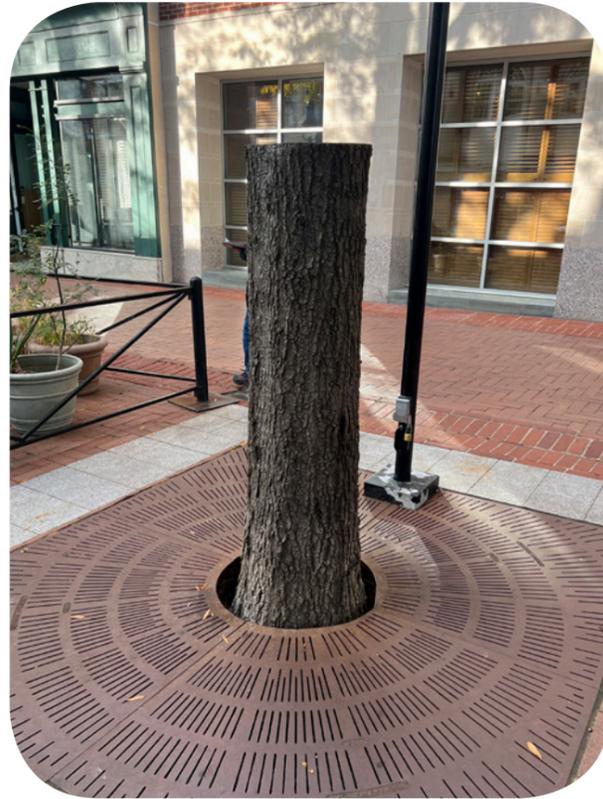
Willow oak #53

The original trees planted in 1976 as part of the Downtown Pedestrian Mall have reached their zenith and are beginning to decline. Sixteen of the planted trees (12%) of the Mall have been removed in the past decade and their loss is notable on the vitality of certain areas. It is particularly notable in groves where the majority of the grove has been removed such as at Central Place and outside of the Market Street garage.

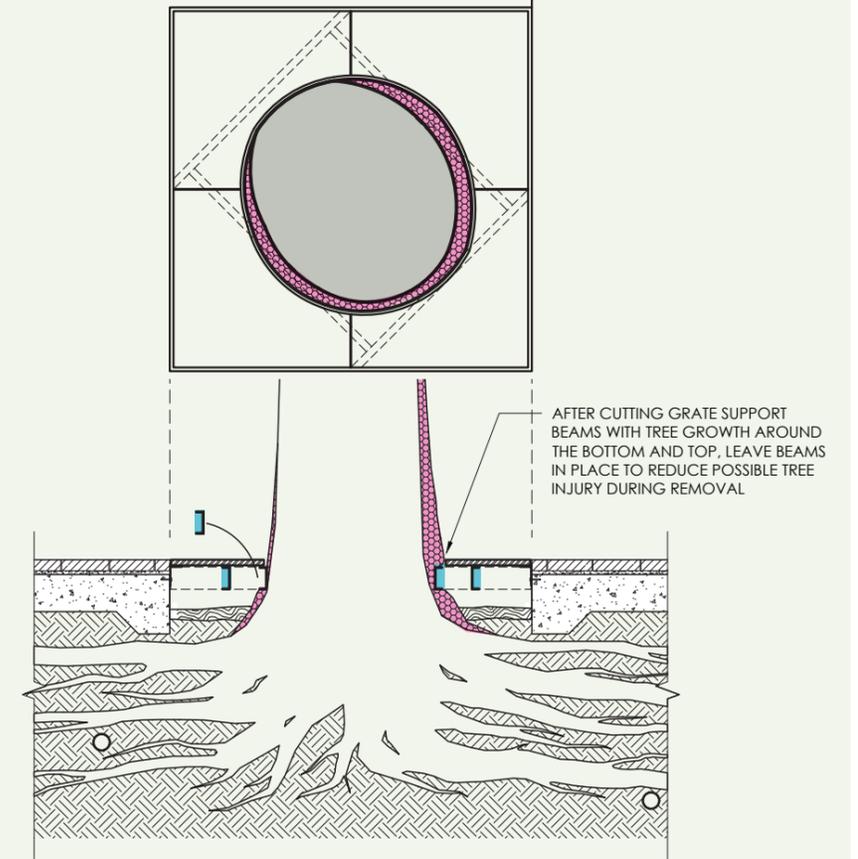
- Tree trunk growing over grate beam support

- Modify grate beams to reduce future conflict

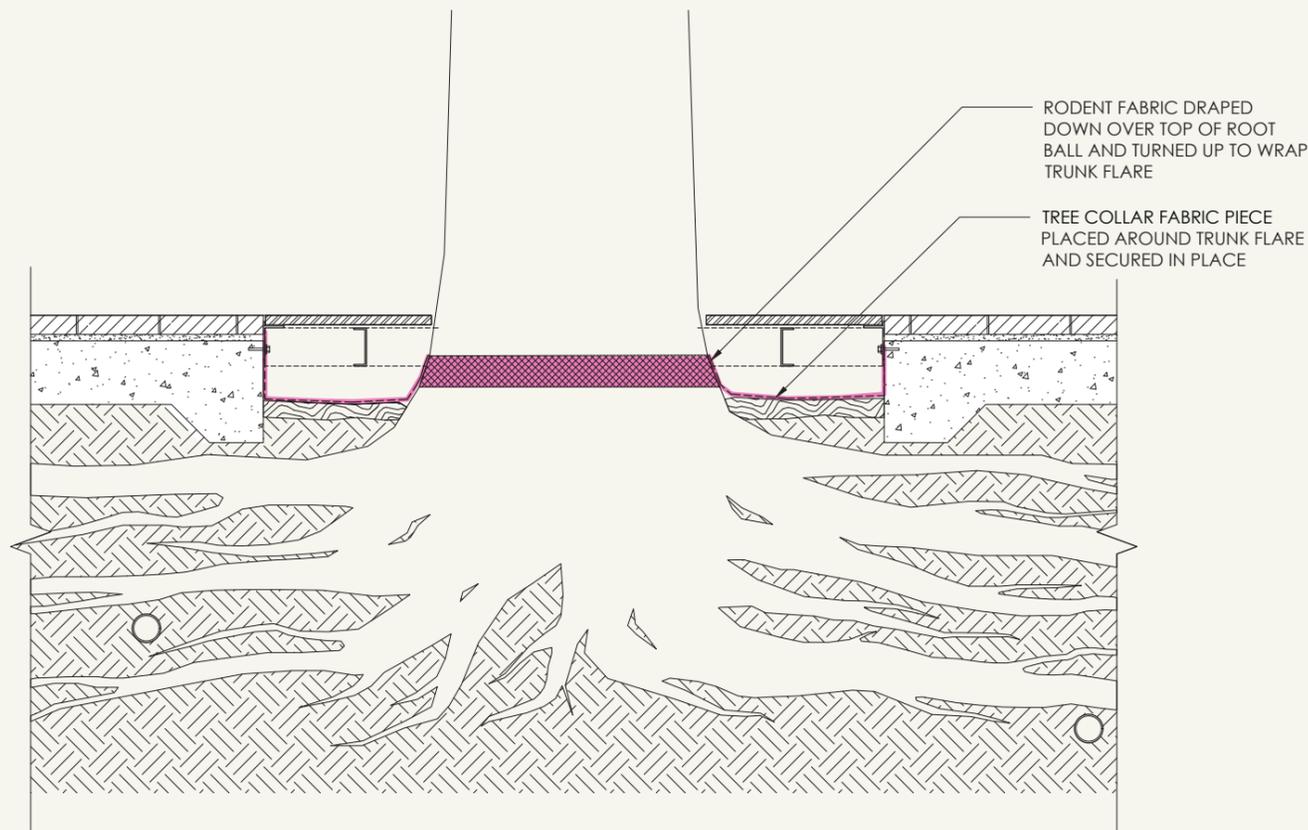
The 2010 grate modification repositioned the light fixtures with their bases above grade, creating a trip hazard. It is recommended to move the light fixtures to the corners to increase the distance from the tree and lower the footings so they are flush with the grade.

It is recommended to install rat barriers to prevent rats and other rodents from using tree wells as pathways beneath the concrete slab.

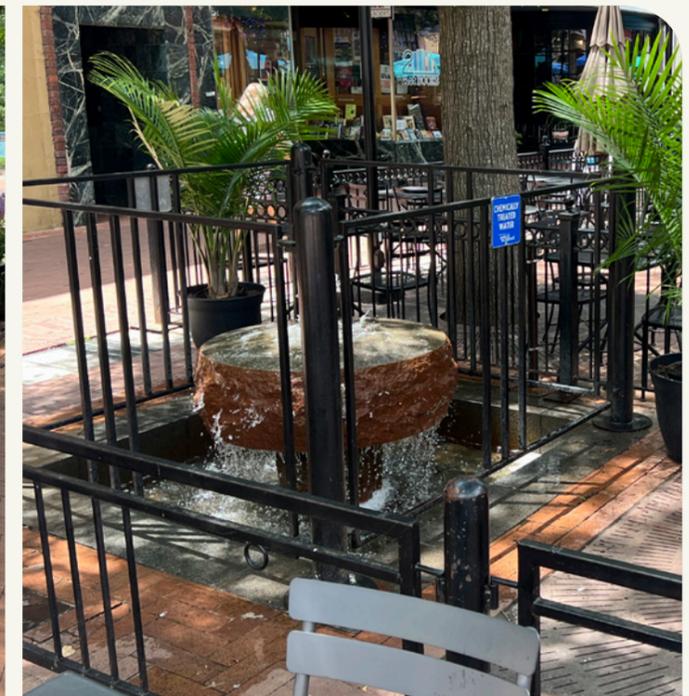
Cafe Fencing

- Cafe fencing blocks the access to public fountain and obscures its visibility

To improve the experience, reallocating cafe seating, reducing visual clutter, and restoring access to the fountains is recommended. These changes would enhance visibility of the tree trunks and provide pedestrians with direct access to the fountains, enriching their experience of the Mall.
